AIR ACCIDENTS  
INVESTIGATION INSTITUTE  
Beranových 130  
199 00 Prague 9 – Letňany

CZ-23-1410

# FINAL REPORT

**Investigation of causes of an air accident  
of the VL-3 Evolution UL aircraft,  
registration mark I-B866,  
in a field near the village of Pěšice  
on 7 December 2023**

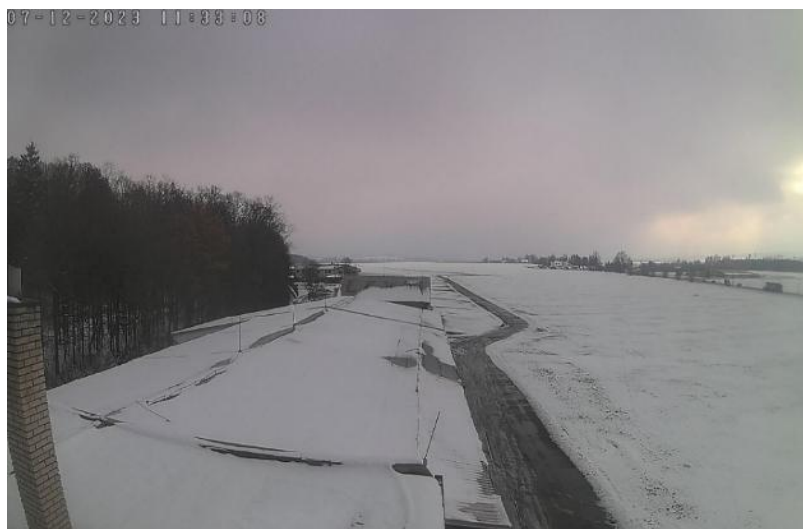
Fig. 3 – Recording from the security camera placed on the aeroclub building at LKVM (southeast view 24 min after landing from LILF)

During the morning flight from Italy to the Czech Republic, the pilots of the two UL aircraft had already agreed who would fly back with which aircraft and in what order. It was obvious from the recording of the security camera located on the aeroclub operations building and from the testimony of a witness present at the airport that the landing at LKVM on arrival from Italy was probably not entirely under VMC conditions. From the analysis of the EFIS data and the analysis of the meteorological situation, it is likely that the flight in FIR PRAHA was not performed largely in accordance with the Visual Flight Rules in accordance with the national Rule L 2.

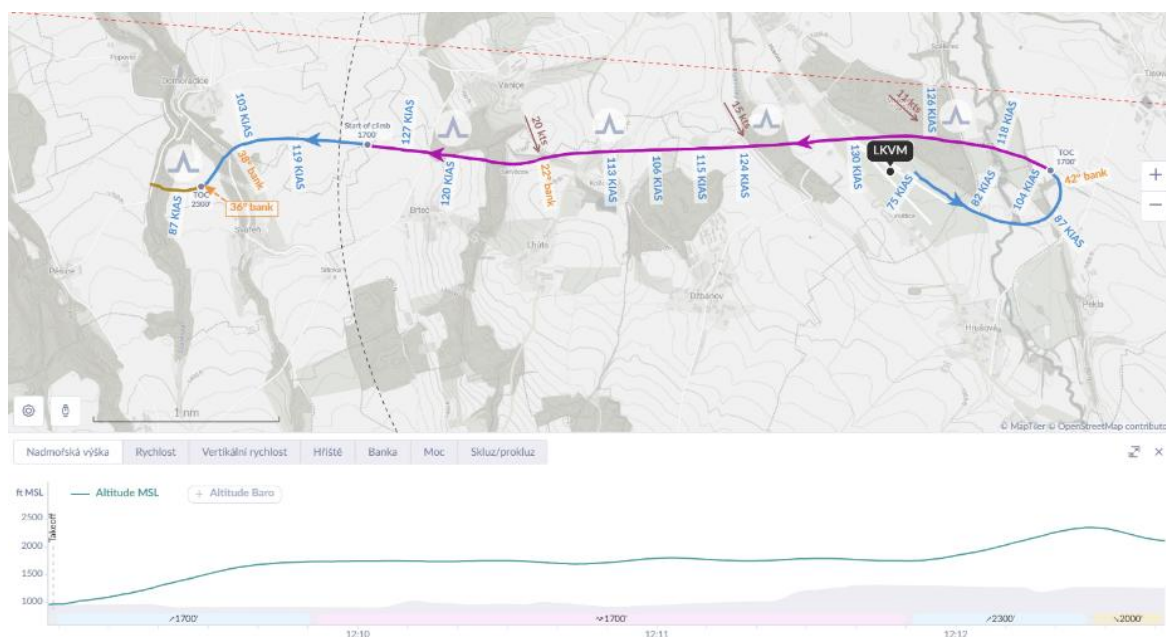
Fig. 4 – Graphic record of critical flight of VL 3 UL aircraft, registration mark I-B866

After take-off from RWY 12L at 12:08:45, the UL aircraft climbed smoothly through a left turn onto a heading of 270°. In the LKVM ATZ, the aircraft maintained an altitude of approximately 1,700 ft MSL and its airspeed ranged from 106 to 130 KIAS. At the west edge of the ATZ at 12:11:56, it flew at 126 KIAS on a heading of 270° and initiated a climb, ascending to 2,000 ft MSL with a drop in airspeed to 100 KIAS. At 12:12:13, it executed a left turn onto a 200° heading at 100 KIAS and reached an altitude of 2,300 ft MSL at 67 KIAS. At 12:12:28, while flying at 67 KIAS, the heading changed to 270°, the altitude to 2,000 ft MSL and the airspeed to 105 KIAS. At 12:12:42 and at a location approximately 1.3 km northeast of the accident site, when the aircraft was flying on a heading of 280°, at an altitude of 2,000 ft MSL and a speed of 105 KIAS, the recording ended.

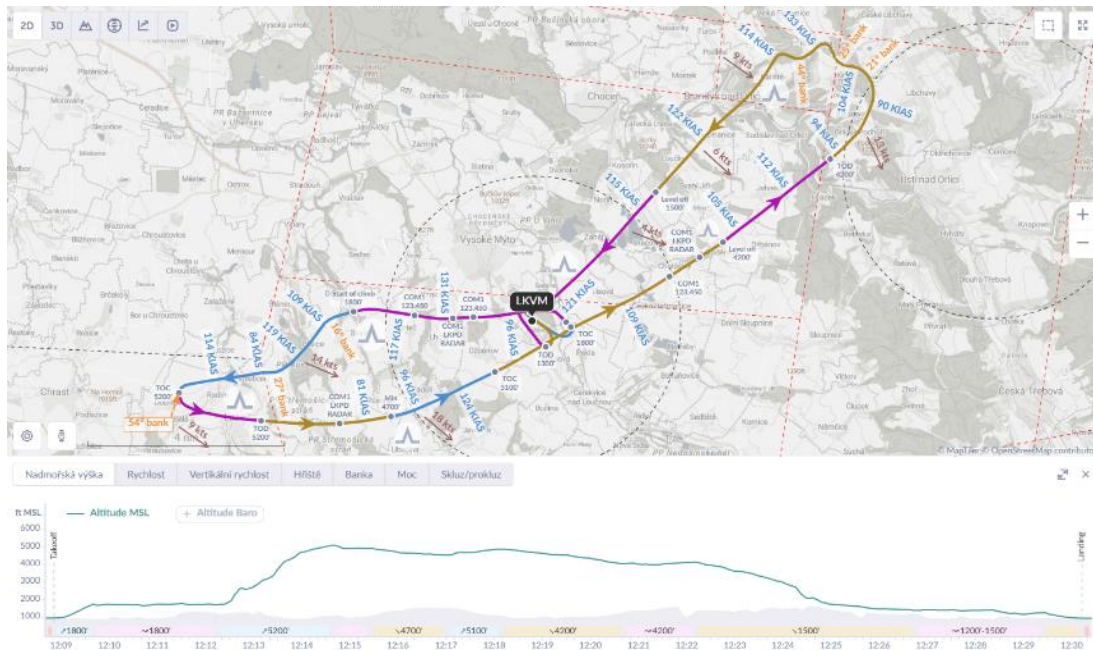
Fig. 6 – Graphic record of critical flight of VL 3 UL aircraft, registration mark I-E402

After take-off from RWY 12L at 12:08:46, the VL 3 UL aircraft climbed smoothly through a left turn onto a heading of 270°. In the LKVM ATZ, it maintained an altitude of about 1,700 ft MSL and its airspeed ranged from 106 to 130 KIAS. After leaving the ATZ on its western edge, it flew at 126 KIAS on a heading of 275°. At 12:12:15, it began an intense vertical climb at a speed of up to 2,000 ft·min<sup>-1</sup> and climbed to 5,000 ft MSL. At 12:14:38 at 5,000 ft MSL, approximately 13 km southwest of LKVM, it made a left turn approximately 180° and returned to LKVM. It passed Vysoké Mýto Airport to the south and continued flying in a northeast direction. At 12:23:05, it entered the LKVO ATZ on its western edge. On the north-western edge of the ATZ, it performed a left turn manoeuvre in an intense descent of approximately 180°. After its termination at 12:25:05, it continued at 1,500 ft MSL on a 220° heading directly to LKVM. It circled above the airport at 300 ft AGL and landed at 12:30:10 on RWY 30R (see Fig. 6).

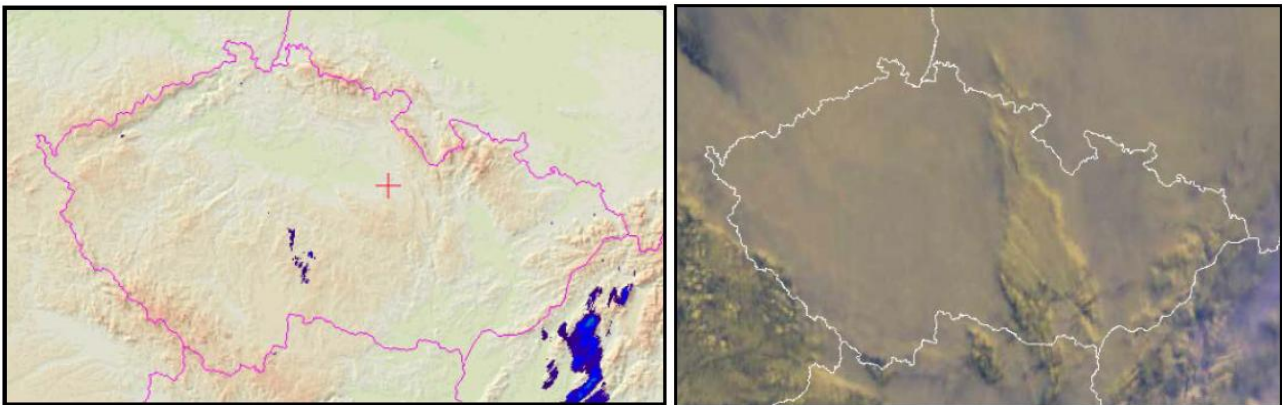
Fig. 8 – Radar and satellite image (the cross marks the accident site)

The wind was blowing mainly northwest at 5 to 10 kt in the area of the air accident near the village of Pěšice at 12:15. Visibility was up to 10 km with occasional mist. The sky was almost cloudy on the whole route of the flight up to the border with Austria with mostly low clouds of ST or SC type. The temperature fluctuated between minus 2 to plus 2 °C. It is likely that frost, which was also predicted from 600 m, may have formed due to the low cloud cover and negative temperatures.

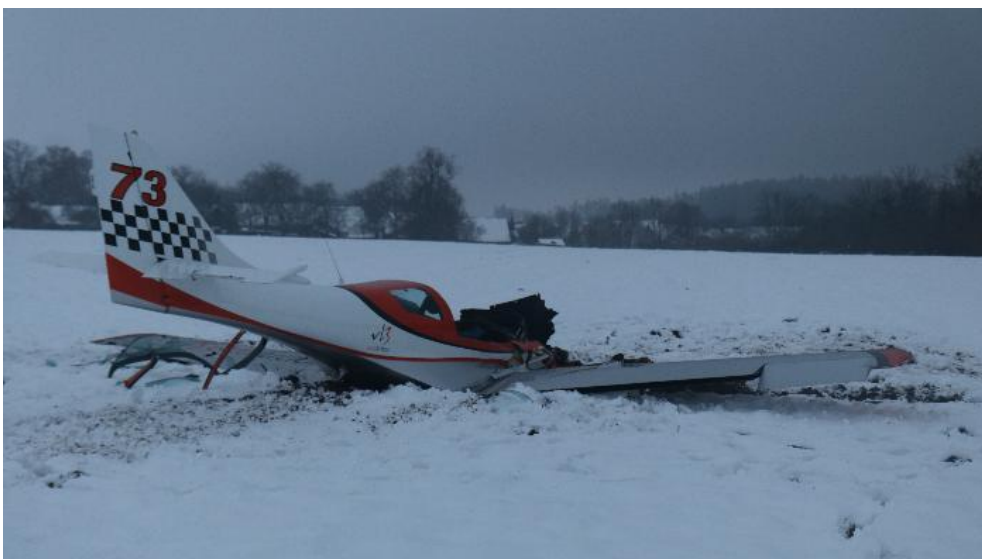
Fig. 12 – UL aircraft wreckage at the accident site

The wreckage of the UL aircraft was lying in the belly-down position, in one place, in one piece. The nose was facing southwest and was partially buried in ploughed, waterlogged soil. The two wing halves remained joined to the fuselage. The flaps and landing gear were in the retracted position. The cockpit canopy was torn from its locking latch and destroyed

by the impact. The deformed frame of the cockpit canopy was broken in the front part and lay behind the left wing half in close proximity to the fuselage. Fragments of the organic glass of the cockpit canopy were located in close proximity to the fuselage. The tail surfaces remained intact, the elevator balancer was in the uppermost position. The elevator and rudder were attached to the control rods and cables. The rudders could be moved freely and were not damaged.

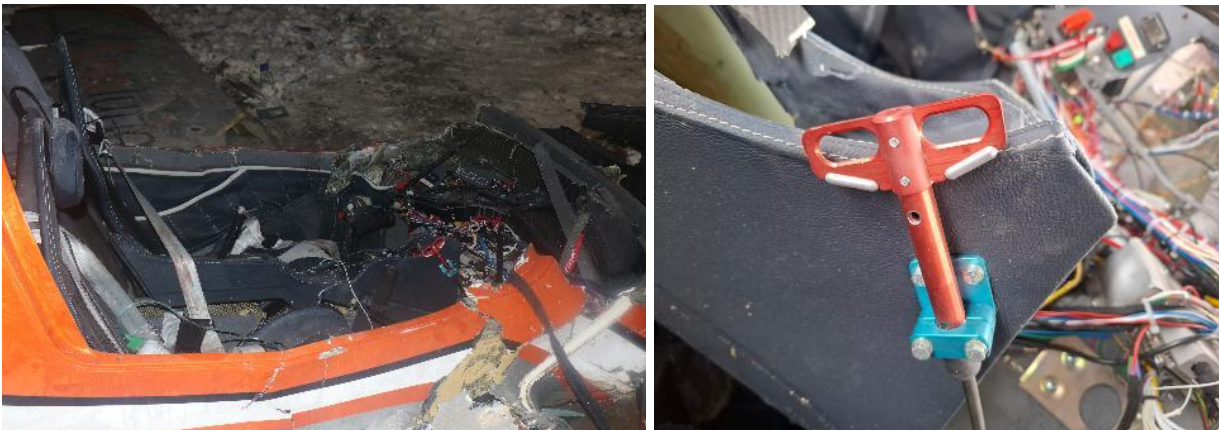
Fig. 13 – Unlocked rescue system activation control

The UL aircraft was equipped with a ballistic rescue parachute system of GRS 6SD ASTM F 2316-12 type. The handle to activate the rescue system was found in an unlocked position, ready for use. The rescue system was manufactured in 2015. The review scheduled for February 2021 has not been carried out.

The UL aircraft was equipped with a ballistic rescue parachute system of GRS 6SD ASTM F 2316-12 type. The handle to activate the rescue system was found in an unlocked position, ready for use. The rescue system was manufactured in 2015. The review scheduled for February 2021 has not been carried out. The system manufacturer has confirmed that this has not adversely affected the functionality of the system.

- lost spatial orientation and control of the aircraft while flying in conditions for which he had not been trained,
- failed to activate the ballistic parachute rescue system upon loss of control of the aircraft,

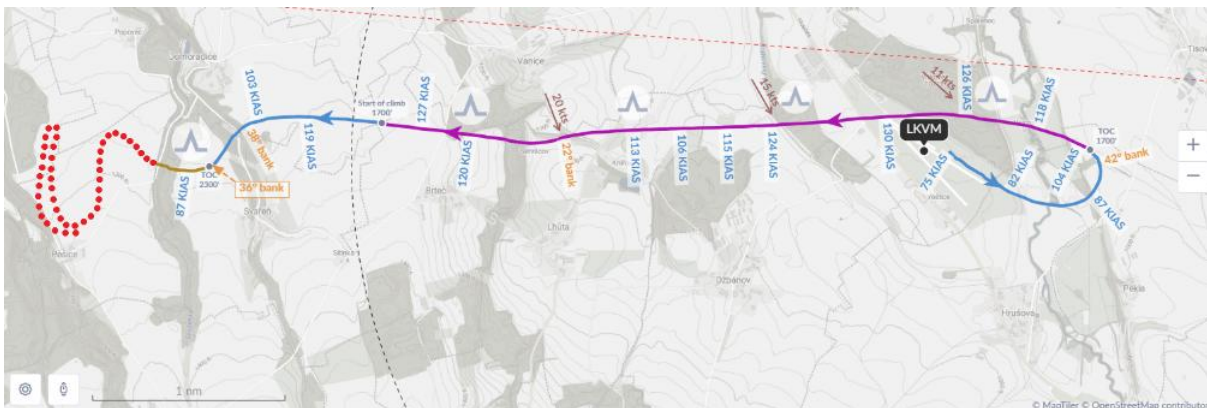
Fig. 14 – Horizontal view of 5 min 25 sec critical flight record (3 min 57 sec of Garmin GDU 460 EFIS record plus 1 min 38 sec of ACC record)

The critical situation arose when the pilot started a climb, during which he flew into the clouds. Instead of attempting to continue his climb on a 275° heading to Pardubice Airport, which was less than 5 minutes away under the given conditions, he began to manoeuvre horizontally (see Fig. 14) and vertically, probably in an attempt to regain visual contact with the ground. During a 2-minute flight in meteorological conditions for which he had not been trained, gross errors in piloting technique occurred. It is clear from the ACC data record that during the changes of altitude there was a dangerous loss of speed twice and the UL aircraft continued to fly only by lucky coincidence. The pilot did not react to the last loss of airspeed at 12:14:20 and the UL aircraft went from an altitude of approximately 1,500 ft AGL (450 m AGL) into a stall-spin. In such situation, which was unresolvable for the pilot, he did not activate the ballistic parachute rescue system but attempted spin recovery. The active effort to pilot the UL aircraft until the last moment was confirmed by the biochemical examination of the somatopsychic condition, from which it can be concluded that the pilot was conscious during the last tens of seconds before the accident, he was undergoing a high physical and mental stress, which turned into an intense stress reaction shortly in the last few seconds. From the finding of tracks on the ground, it is clear that only a stop of rotation low to the ground was achieved, without the possibility to recover the steep descent.
