AIR ACCIDENTS  
INVESTIGATION INSTITUTE  
Beranových 130  
199 00 PRAGUE 9 – Letňany

CZ-21-0308

# FINAL REPORT

**on investigation of causes of an air accident  
of the North American T-28B Trojan aircraft, registration mark OE-ESA,  
near the village of Jickovice, District Písek  
on 20 June 2021**

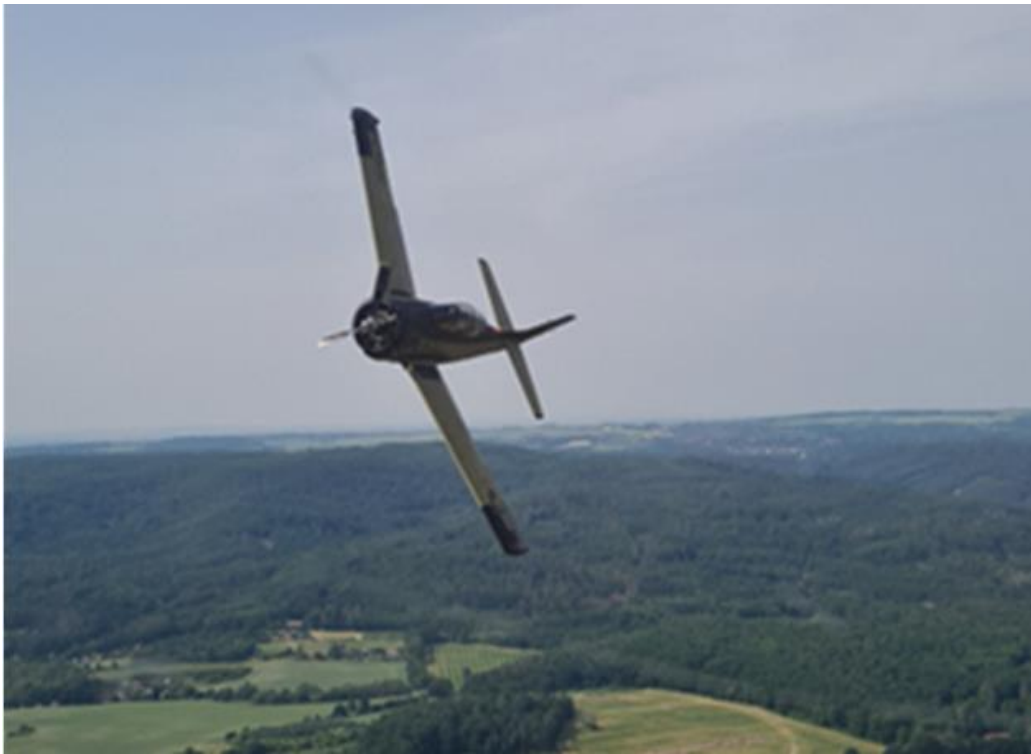
The pilot manoeuvred the T-28B behind the B-25J near the area of wake turbulence. The photographer in the T-28B took in-flight photographs and cell phone video footage. Photographs taken from the T-28B by the photographer showed the close relative position of the aircraft behind each other in the group. There were two cameras on board the T-28B, in the rear part of the cockpit (photographer's position).

Fig. 3 – Manoeuvring the T-28B behind the B-25J

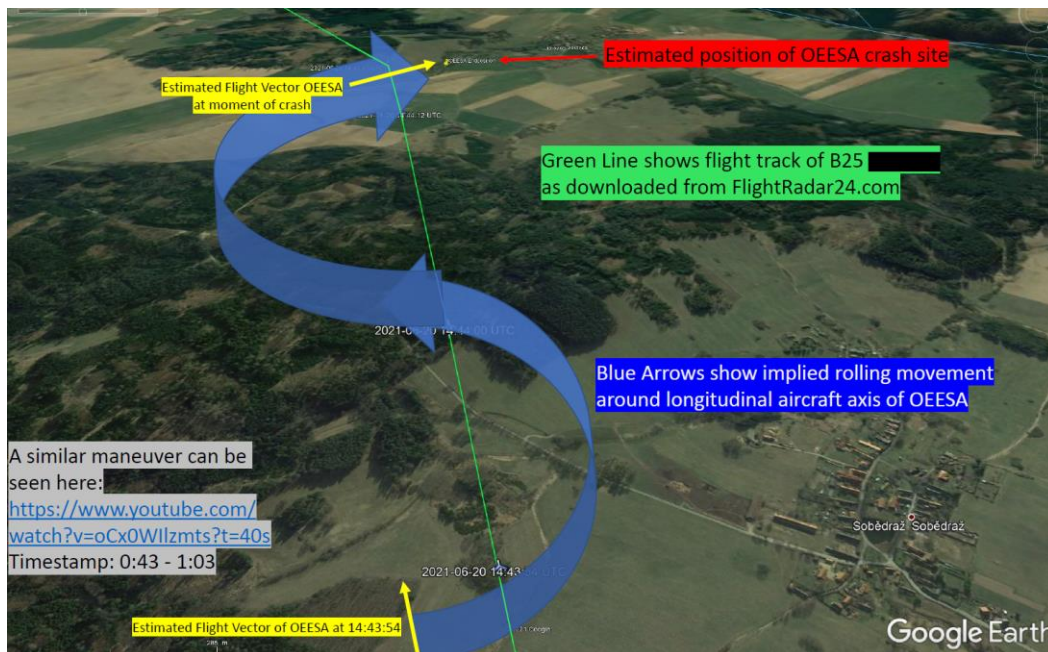
The witness from the B-25J plotted and timed the trajectory of the T-28B barrel roll on a map base, see Fig. 5. The barrel roll began at 14:43:54. At 14:44:00, the aircraft was in the inverted attitude and, at 14:44:12, it was in the descent recovery phase. The witness timed the critical phase of the flight as long 18 seconds.

Fig. 5 – Trajectory of the barrel roll plotted and described by the B-25J witness<sup>1</sup>

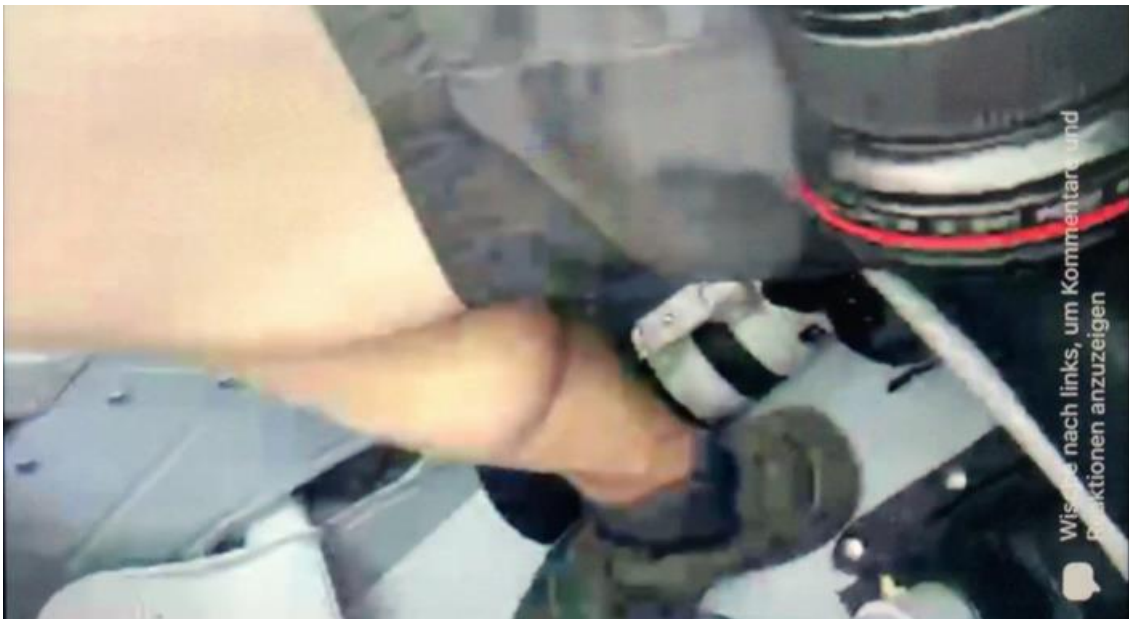
1. Was it usual for you to fly with your camera on the floor, leaning against the side of the cockpit and held up by your foot? Situational video footage showed the camera lying loose, held by a foot.

Fig. 6 – Position of the camera on the floor and the second camera in a vertical position

The photographer's testimony revealed that he had no idea that the pilot would suddenly decide to perform an aerobatic manoeuvre at an altitude of about 150–180 m AGL. The photographic device weighing about 3 kg was lying on the cockpit floor and the photographer was holding it down with his foot only. The loss of positive gravity load factors and the effect of negative ones, for example, in the aircraft's inverted attitude, thus clearly caused the heavy camera to move uncontrollably around the cockpit. As the T-28B's cockpit is not separated by any dividing partition, and the aircraft was slowing down, it is very likely that the camera could have been moving in the cockpit. It is uncertain whether the T-28B pilot was simultaneously aware of the risk associated with the T-28B's relatively heavy fuel load. He probably had no idea, or forgot, that the photographer had a heavy and bulky camera on the floor in the back of the cockpit.

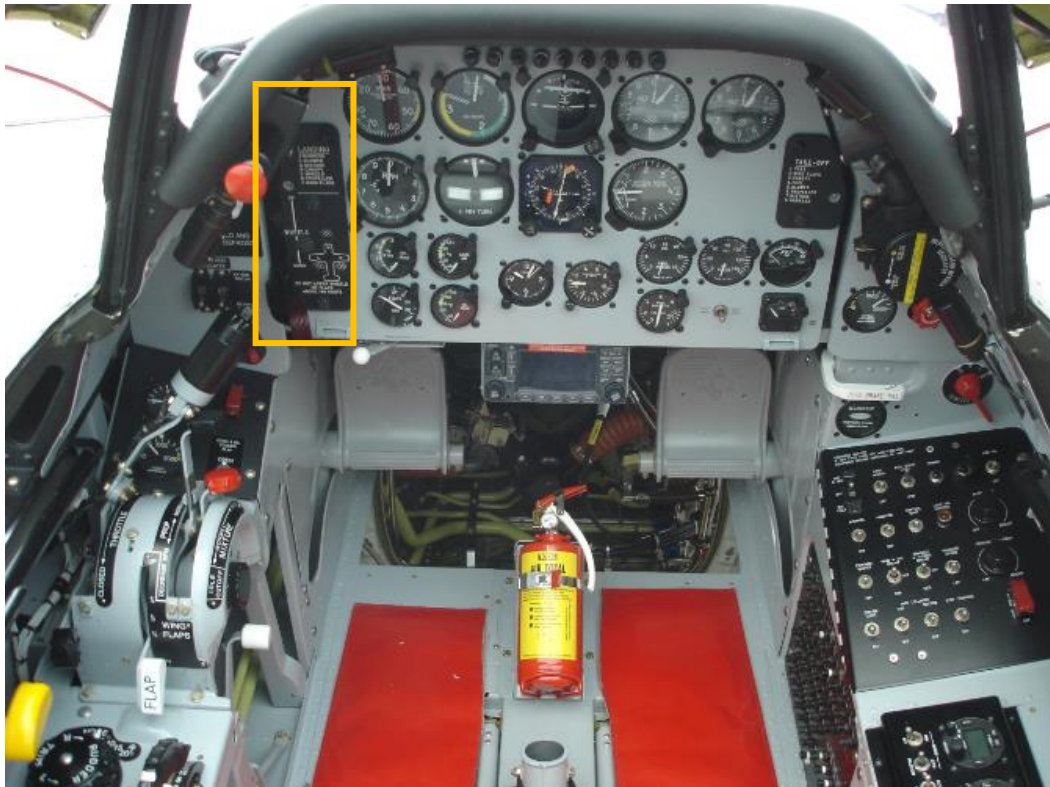
The original T-28B OE-EA cockpit is shown in Fig. 7 with the aircraft controls and systems. The landing gear control lever does not have a latch. Cycle length of 4–6 sec for landing gear extension is described in the Flight Manual<sup>5</sup>.

Fig. 7 – Landing gear control in a yellow frame

In order for the landing gear to extend, the landing gear control lever **had to** be moved at least a bit from the extreme upper position to release the locks on the retracted position of the landing gear. Due to the time of 4–6 sec stated in the Flight Manual of the type needed for extension, it was necessary to move the landing gear lever from the upper position to the lower position probably after putting the aircraft to climb and start of the barrel roll spinning. The impact of both wing halves into trees and their separation from the fuselage caused the **break of the hydraulic system tubes and thus the break of the landing gear control**. It could not be satisfactorily determined from the known facts at which stage

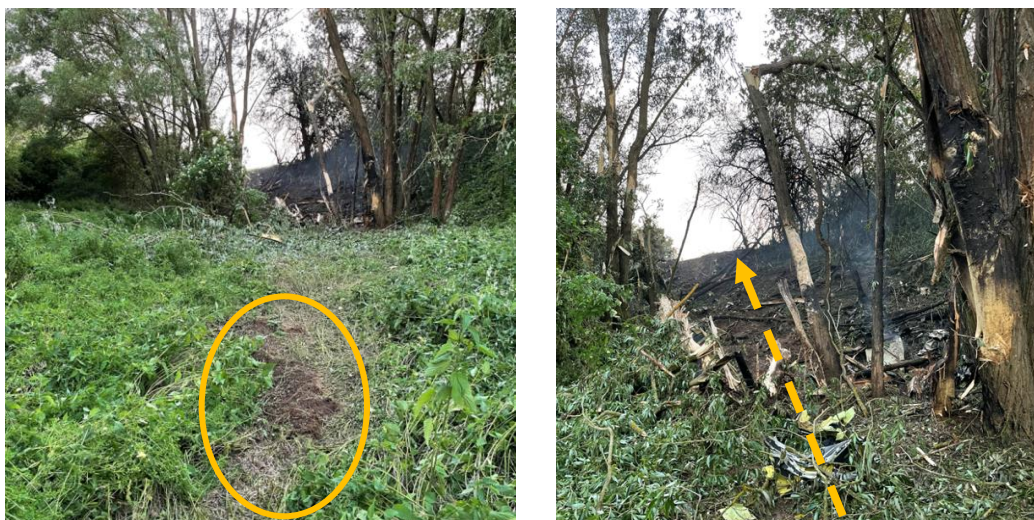
The aircraft, while recovering from a descent, flew through the tree tops of the forest belt at the beginning of a ravine. The first contact of the aircraft with the terrain was around the nose gear (Fig. 10, left). This was followed by an impact with the right half of the wing into mature trees on the right slope of the ravine (Fig. 10, right), causing extensive damage to the structure of the aircraft and a fuel leak from the ruptured tanks. At a distance of about 4–5 m to the left of the first contact with the trees, a mature tree, the trunk of which was about 40 cm in diameter, was struck and severed by the impact.

Fig. 10 – Contact of the nose gear wheel tyre with the ground (left) and the point of impact of the aircraft into trees in rising terrain relief (right) with an arrow showing the direction of wreckage movement after impact

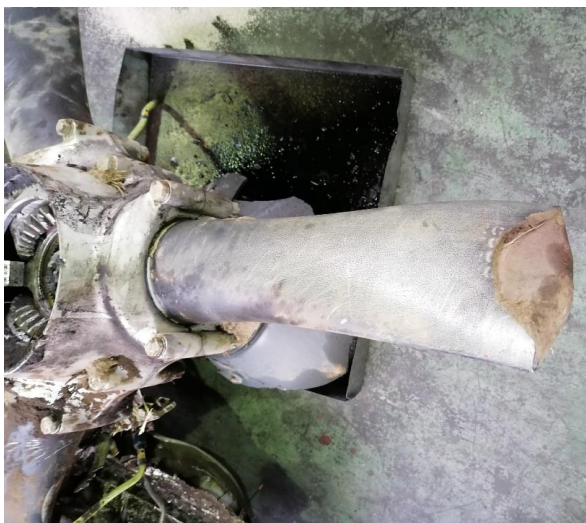
The three-bladed adjustable metal constant-speed propeller was badly damaged. All the damage was caused by the propeller coming into contact with trees and hitting the slope of the ravine. One propeller blade was broken off at about two thirds of the blade length. The fracture was of a brittle nature, i.e., it was caused by a short but intense inertial forces during the impact (Fig. 11). The second propeller blade (Fig. 12) was damaged at the leading edge, corresponding to the blade probably having come in contact with trees and then the ground. Further damage was found on the trailing edge of the blade. However, these were broken pieces of material, which was consistent with the fact that such damage occurred after the entire propeller had been torn from the engine shaft. The third blade (Fig. 13) sustained relatively the least damage. The blade was slightly bent backwards and sustained some damage in the form of small nicks in the final third at the leading edge. The propeller head (Fig. 14) was compact and, judging from the tracks, was broken out of the engine propeller shaft probably by the forces generated when the broken blade struck the ground or vegetation.

Fig. 11 – Broken propeller blade

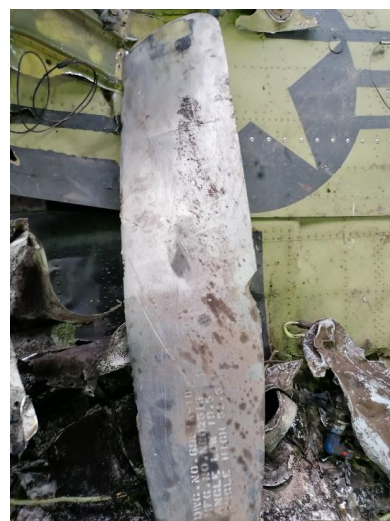
Fig. 12 – Blade with damaged edges

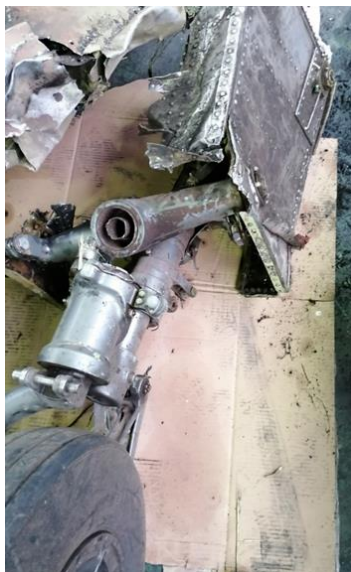
The aircraft landing gear was retractable, wheeled, nose type, controlled by a hydraulic system. There was one wheel on each landing gear leg. The wheels on the main landing gear legs were fitted with lamellar hydraulic brakes and the front wheel was steerable. In the extended position, the landing gear legs were secured by breaking struts and when parked by mechanical pins. In the retracted position, the legs were secured by mechanical locks of the eye-hook type, where the eye is part of the landing gear leg and the hook is located in the landing gear shaft. The first impact with the ground destroyed the front landing gear leg web, ripping it out of the airframe structure (Fig. 15). The leg had an undamaged retracted position lock eye. The nose wheel tyre was damaged and bore traces of soil on its surface from the first contact of the aircraft with the ground.

Fig. 15 – Damage to the front landing gear leg.

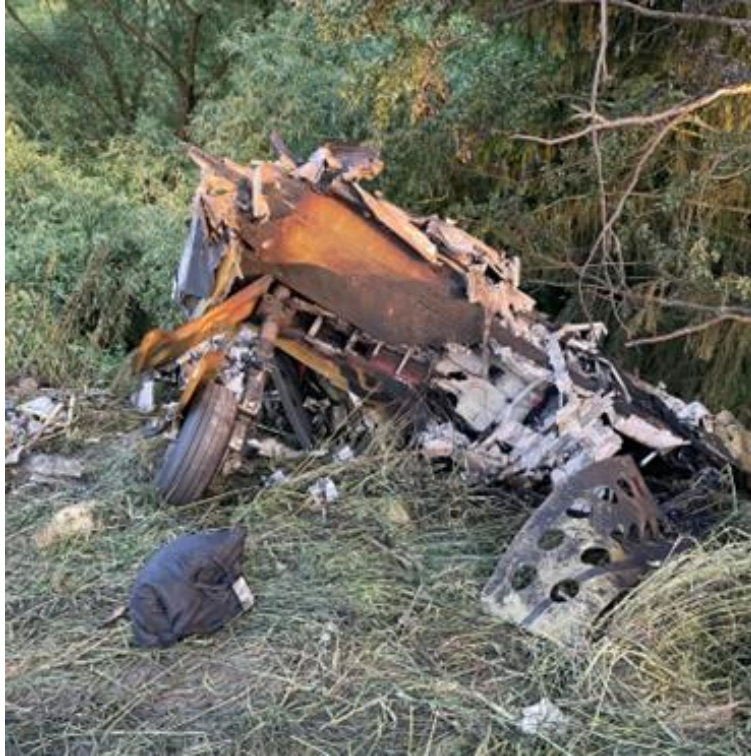
The right main landing gear leg (Fig. 16) remained fixed in the remains of the right wing half structure and was in a nearly extended position. The eye of the retracted position lock was clean and undamaged. The landing gear covers were partially deformed. The counterpart of the retracted position lock bore traces of fire, but was not deformed or otherwise mechanically damaged (Fig. 17). The hydraulic brake piston blocks bore the marks of impact with trees and the ground.

Fig. 16 – Wreckage (remains) of the aircraft after impact destroyed by fire

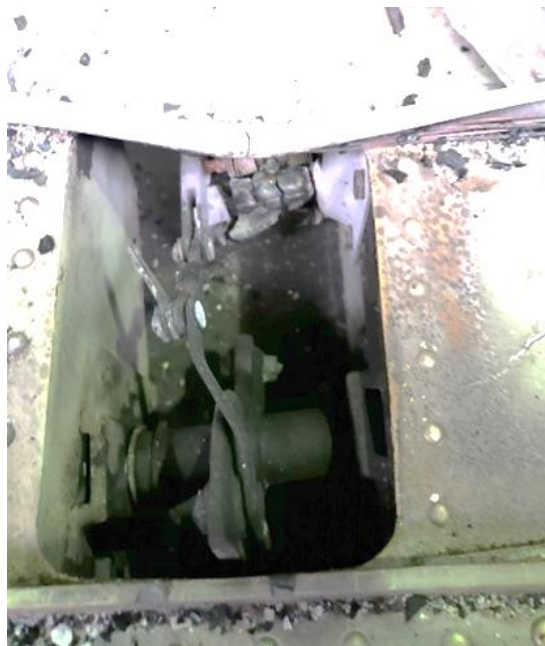
Fig. 17 – Right landing gear leg lock hook

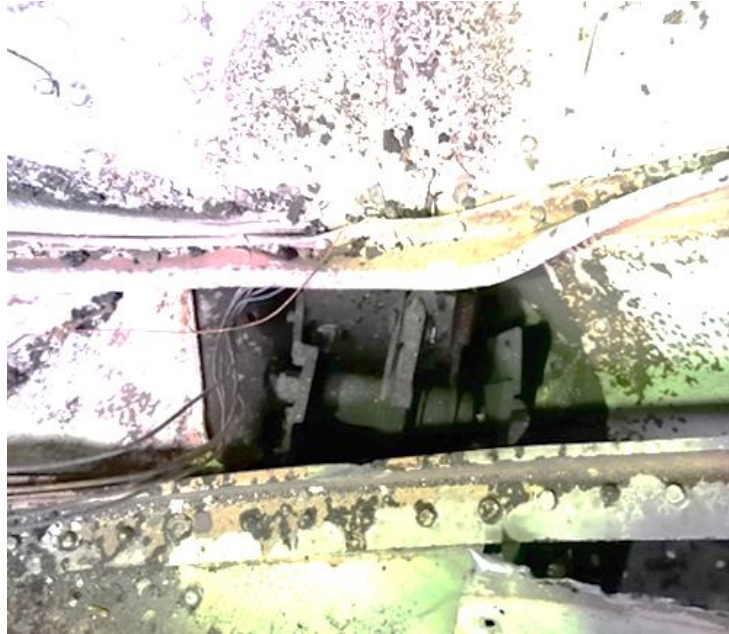
The left main landing gear leg was torn out of the wing structure. The position of the left main landing gear leg could not be determined. The lock eye of the retracted position was severely deformed by an impact with a tree. The hydraulic brake piston blocks bore the marks of impact with trees and grass clumps from the place of the first impact. In the fragment of the left half of the wing, in the landing gear shaft, the retracted position lock hook was found, which also carried traces of fire, but was not deformed or otherwise mechanically damaged (Fig. 18).

Fig. 18 – Left landing gear leg lock hook

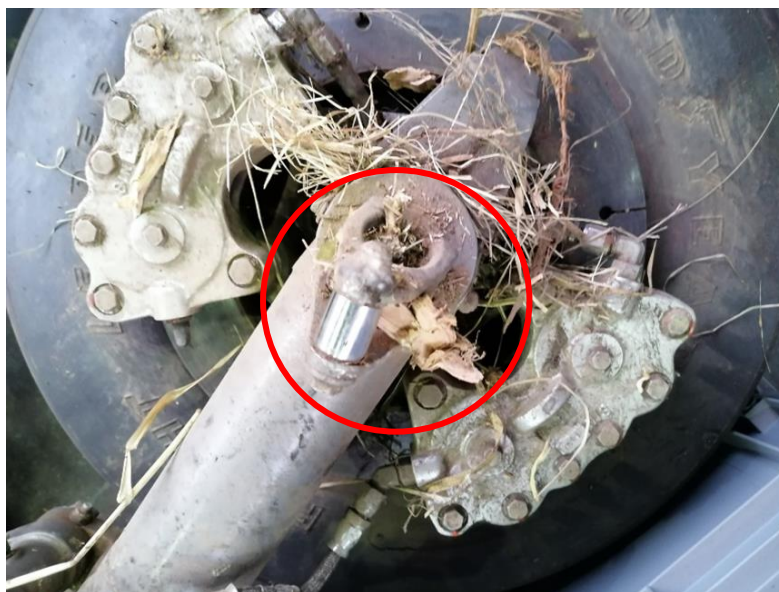
The heavily wedged wooden splinters under the roller of the left landing gear retracted position lock eye proved the contact of the landing gear with the trees, i.e., that the legs of the main gear were in a position close to full extension when hitting the trees (Fig. 19).

Fig. 19 – Wooden splinters wedged in the left landing gear leg lock eye

The nature of the damage to the landing gear locking mechanism on the landing gear legs and in landing gear shafts – intact condition of the left and right landing gear leg lock hooks, which were not bent or seriously damaged, and **wooden** chips in the left landing gear leg lock eye are indicative of extending of the landing gear prior to impact with the trees. The landing gear was in a nearly extended position when it hit the trees. **Traces of the first contact of the nose wheel tyre with the ground also testified to the extension of the landing gear** before hitting the trees.

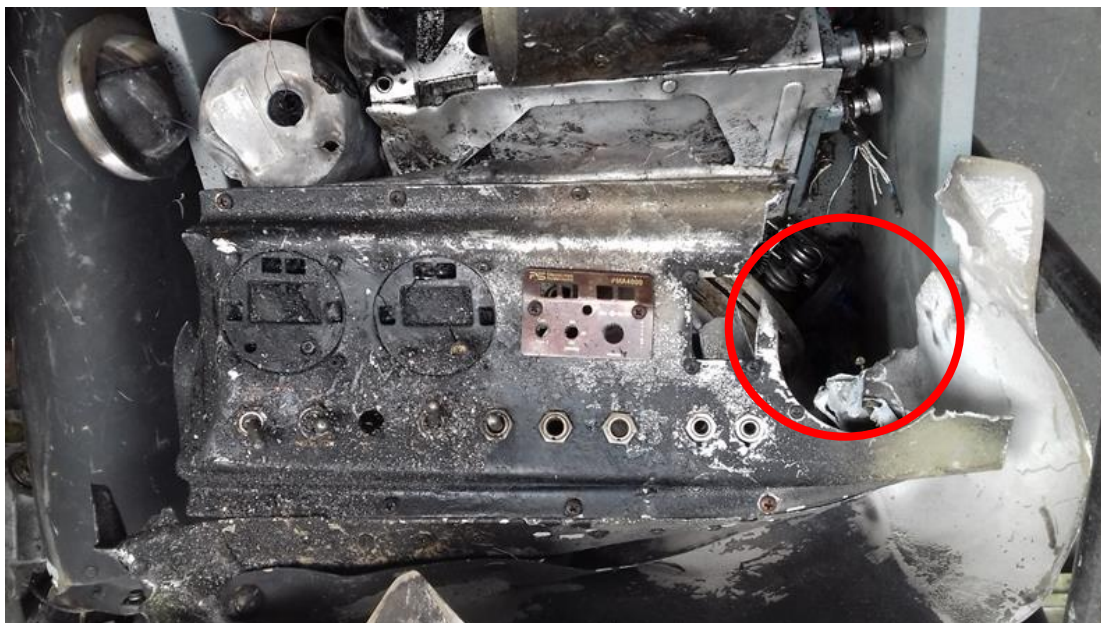
The control panel bore marks of destruction and fire. *The Engine Monitoring System* was ripped out and completely destroyed by fire. Engine monitoring systems use sensors located at various places on the aircraft engine to gather information about engine performance. The sensors provide pilots with real-time information on engine operation and also capture data for analysis of engine performance over time.

Fig. 20 – Control panel destroyed and missing *Engine Monitoring System*
