CZ-23-1016

# **FINAL REPORT**

**of serious incident  
of aircraft Boeing 767-332ER(WL)  
registration N175DN  
on 1<sup>st</sup> of September 2023  
during initial climb from LKPR**

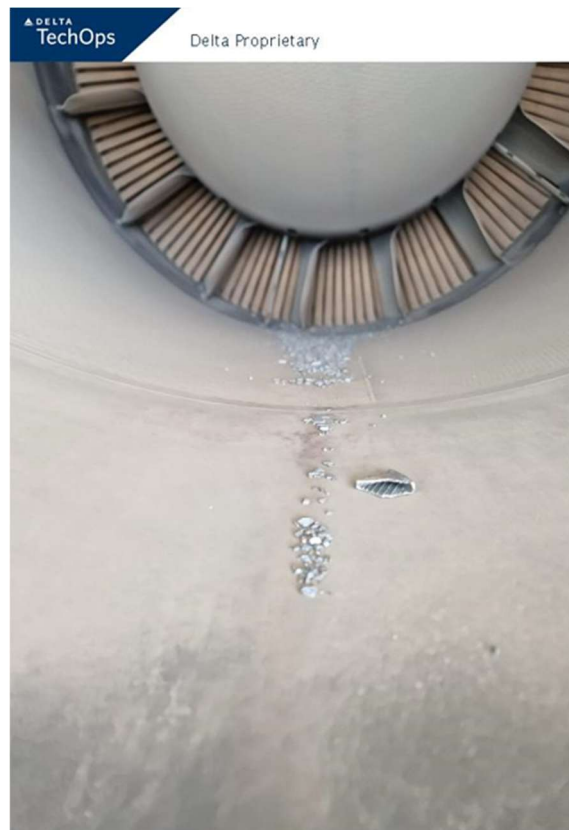
A preliminary maintenance inspection of the right engine performed immediately after the flight identified contained damage and metal fragments in the engine exhaust/tailpipe.

Fig. 2: State of the engine exhaust/tailpipe after landing at LKPR

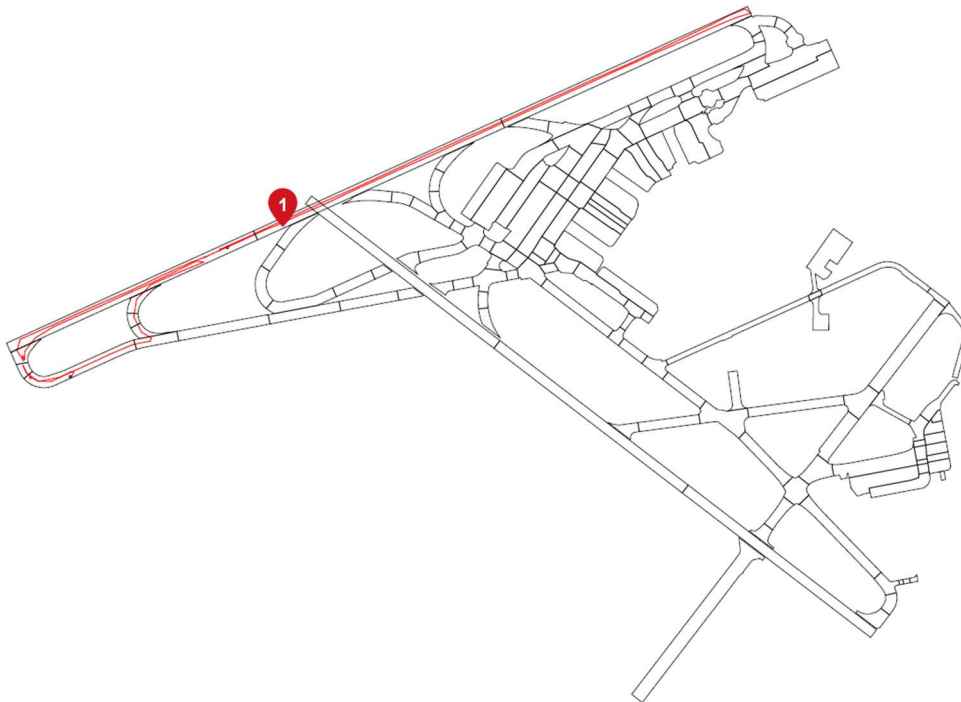
11:26: Metal fragment found approx. 150 m behind the cross RWY 06/24 and RWY 12/30 in the direction of RWY 24 on the right side from the runway centreline.

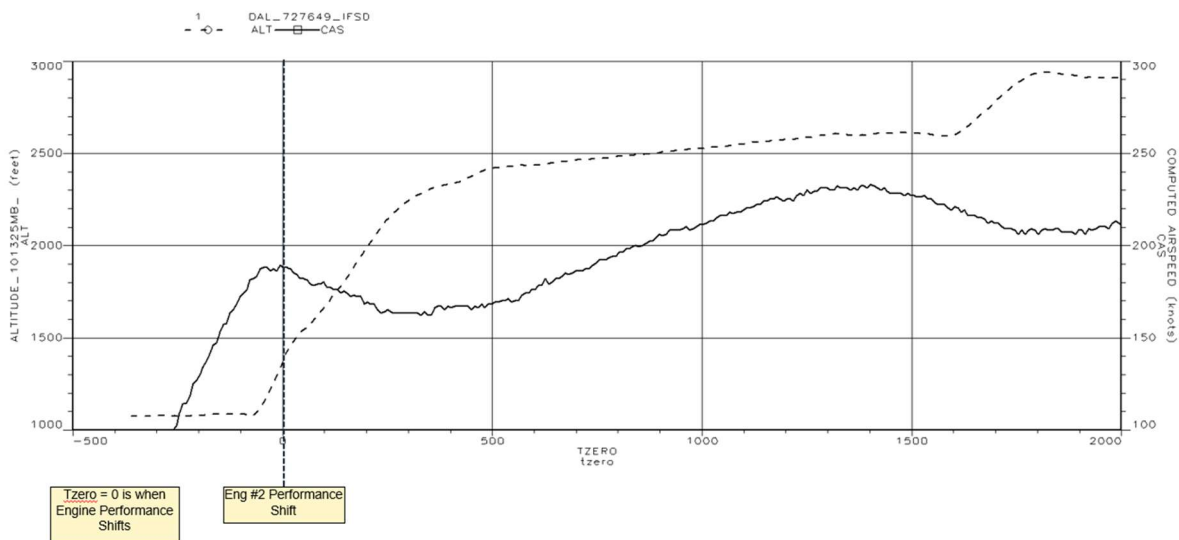
**GAS PATH PARAMETER SHIFT OCCURS JUST AFTER LIFT OFF AROUND 190 KNOTS**

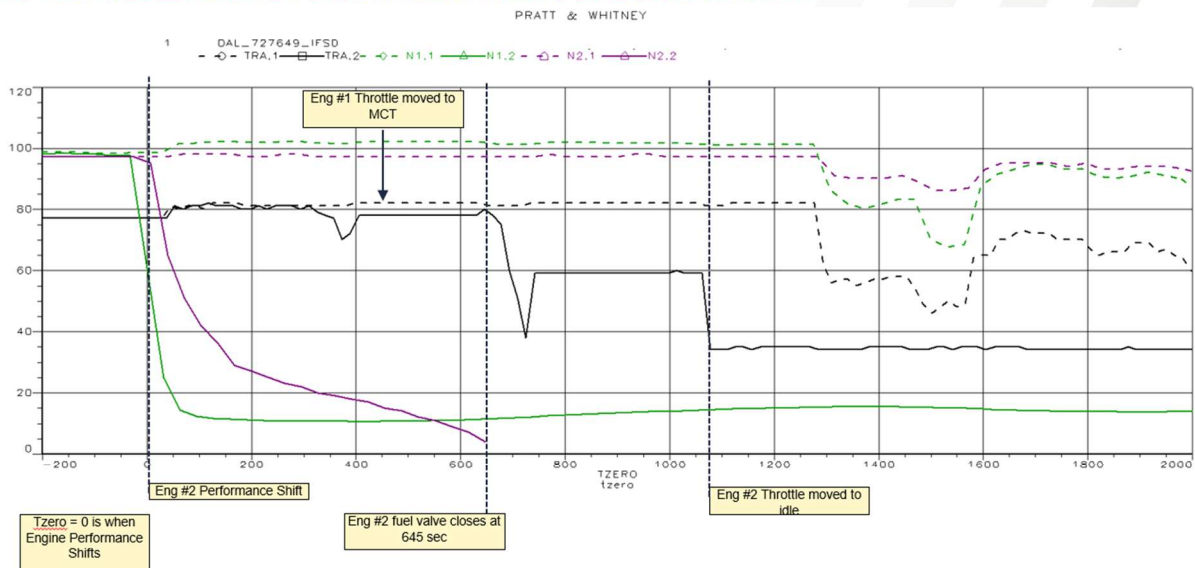
### GAS PATH PARAMETER SHIFT SEEN AT TZERO WITH NO CHANGE IN THROTTLE

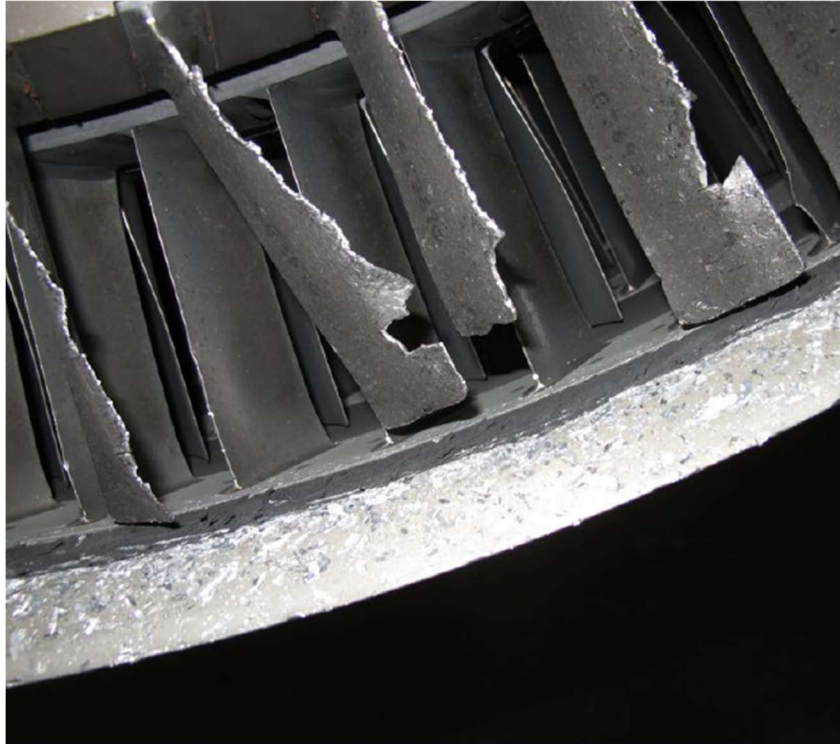
*The LPC S4 blades exhibited 360 degree trailing edge impact damage including material loss and tearing. One LPC S4 blade tip was separated at approximately 3/4 blade span. The LPC S4 blade leading edge and LPC S3 vane trailing edge surfaces had minor nicks and gouges at random locations.*

LPC S4 Rotor Blades – Trailing Edge Damage, Blade Tip Separation

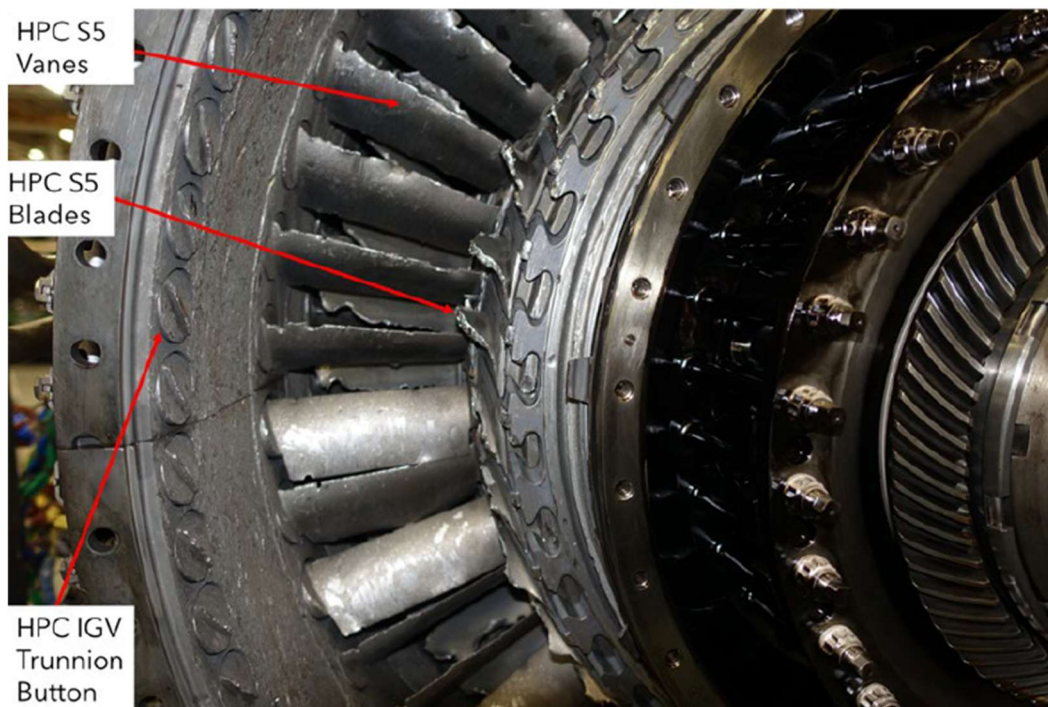
*The HPC inlet guide vanes airfoils were all separated and fragmented. The HPC S5 blades were all fractured near the blade platform. The blade fracture surfaces all appeared jagged and irregular in shape.*

HPC IGV Trunnion Buttons, HPC S5 Blade Fractures, HPC S5 Vanes

*The HPC S5 vanes were all full length but exhibited leading and trailing edge impact deformation. Three consecutive HPC S5 vanes were rotated out of schedule relative to the other vanes between the 3 and 4 o'clock positions, consistent with secondary impact damage. Three consecutive HPC S6 vanes between the 5 and 6 o'clock position were missing. The trailing edge of all remaining HPC S6 vanes were thermally damaged and partially consumed in a scallop shaped pattern from the midspan to the outer diameter platform. The HPC S7 vanes were thermally consumed. Resolidified metal slag was adhered to the case halves from the HPC S6 vane trailing edge aft. There were no punctures or burn through on the HPC split case outer air seals.*

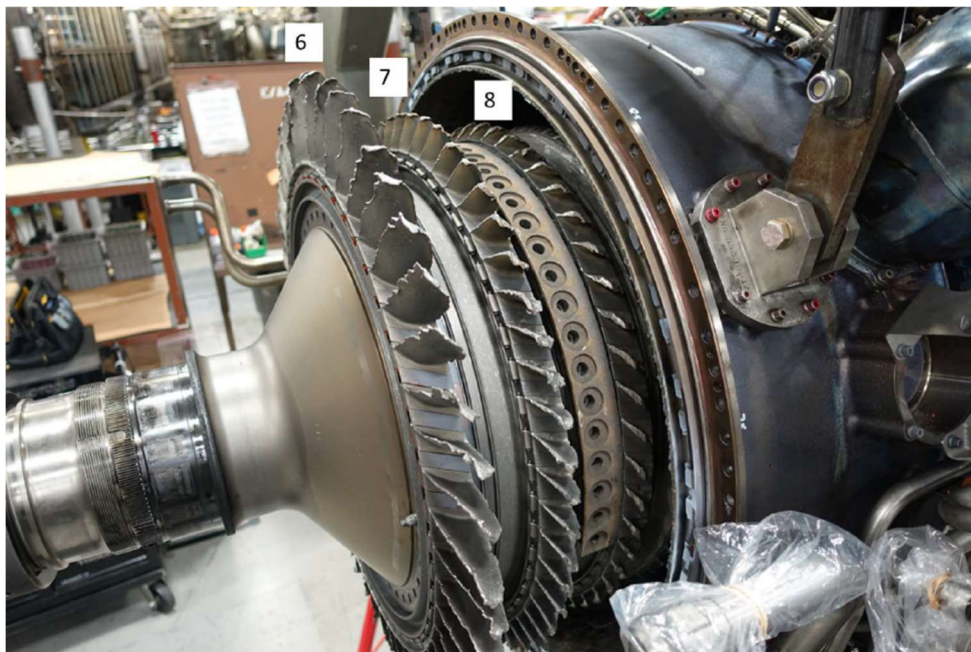
*The HPC S6 blades appeared to be all full length but exhibited deformation and material loss on the leading edge, trailing edge, and tip. The HPC S7 blades were all separated at the midspan, and what remained of the blade airfoils was smeared with indications of incipient melting.*

HPC S6, S7 and S8 damage

*The visible HPC blades and vane stages aft of S7 were consumed consistent with a compressor fire. Resolidified metal slag was adhered around the HPC aft case outer*

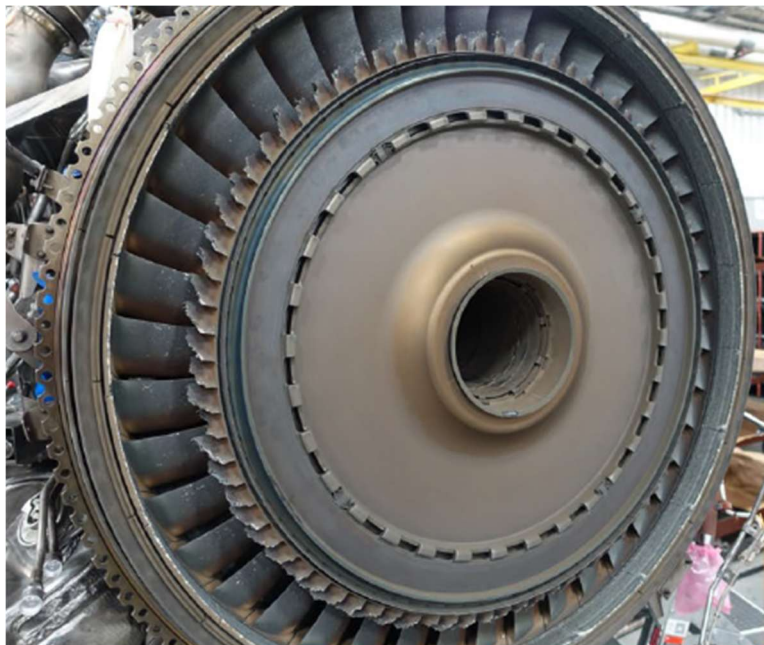
*The HPT S2 blades were all fractured at 1/4 span and the fracture surfaces appeared jagged and irregular. There were no punctures or deformation observed on the HPT S2 blade outer air seals. With the exception of minor chipping, the blade outer air seal thermal barrier coating was intact. The HPT S2 vanes were all intact with light suction (aft) side impact damage. Light metal spray was adhered to the HPT S2 vane surfaces. The HPT S1 blades visible forward of the HPT S2 vanes, had resolidified metal slag accumulated along the trailing edge blade path 360 degrees around the engine.*

HPT S2 Blades and Vanes

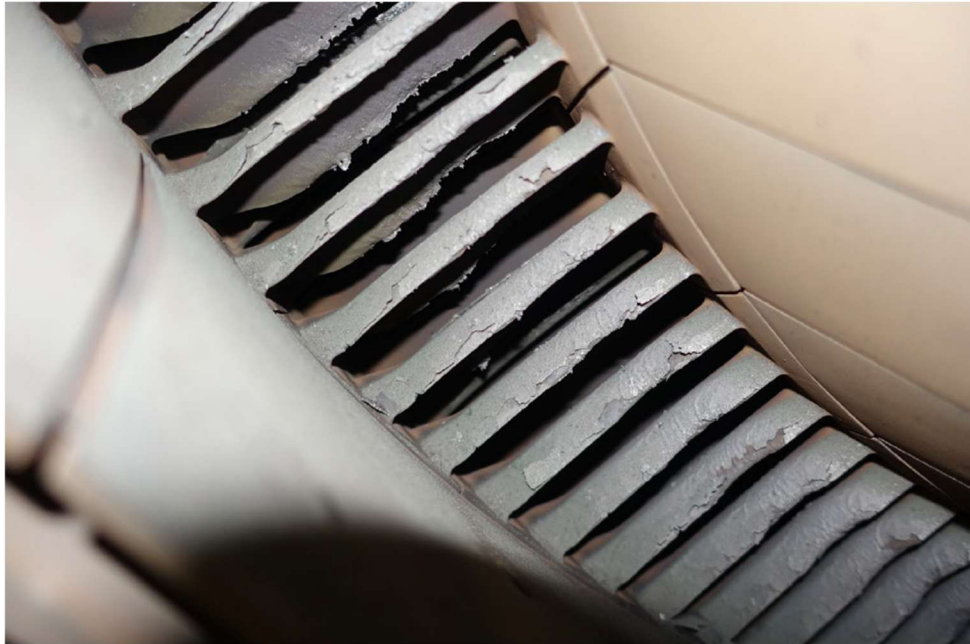
*The LPT shaft was in good condition with no evidence of rub damage. The LPT S3 vanes were full length with indications of thermal distress including bubbling/flaking of the diffused aluminide blade coating. The LPT S3 vanes also had material buildup on the suction side of the vanes near the leading edge. HPT S2 blade fragments were collected at the 6 o'clock position of the LPT/transition duct and on the pressure side of the LPT S3 vanes from the 5 to 9 o'clock positions. There was leading edge impact damage and material loss visible*

LPT S3 Vane, Thermal Damage and Vane Coating Flaking

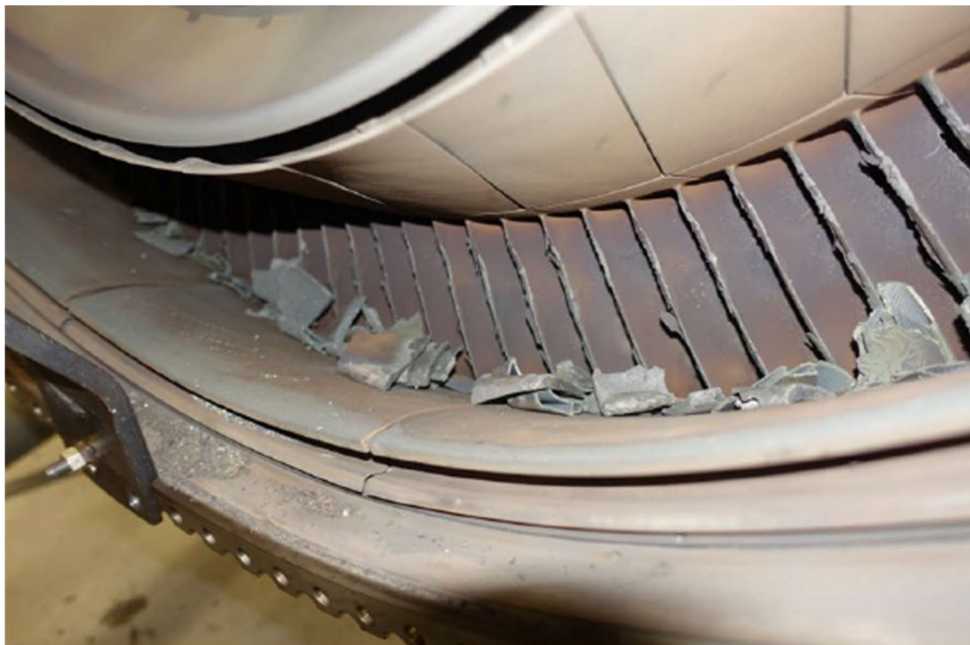
Metal Debris Accumulation on LPT Module Transition Liner
