AIR ACCIDENTS  
INVESTIGATION INSTITUTE  
Beranových 130  
199 00 Prague 9 – Letňany

CZ-23-1410

# FINAL REPORT

**Investigation of causes of an air accident  
of the VL-3 Evolution UL aircraft,  
registration mark I-B866,  
in a field near the village of Pěšice  
on 7 December 2023**

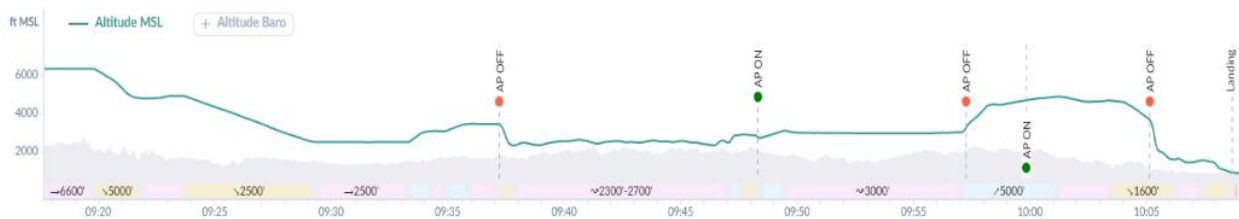
According to the UL flight data record, VL 3 UL aircraft, registration mark I-B866, took off from LILF at 06:41 and continued its flight to the Czech Republic via Switzerland and Austria. It entered FIR PRAGUE at 09:16 in the area west of the Lipno dam at the altitude of 6,600 ft MSL. It gradually descended to an altitude of 2,500 ft MSL, which it reached at the western edge of the LKJH ATZ. At the altitude of 2,500 ft MSL, it continued to the LKPI ATZ where it began a smooth climb to 5,000 ft MSL. At this altitude, it entered the LKVM ATZ. The pilot turned off the autopilot (AP OFF) during the descent at the altitude of approximately 4,000 ft MSL and after performing the landing manoeuvre shown in Fig. 2, landed on RWY 30L LKVM at 10:09.

Fig. 1 – Flight altitude profile of VL 3 UL aircraft, registration mark I-B866, in FIR PRAGUE during flight from Italy

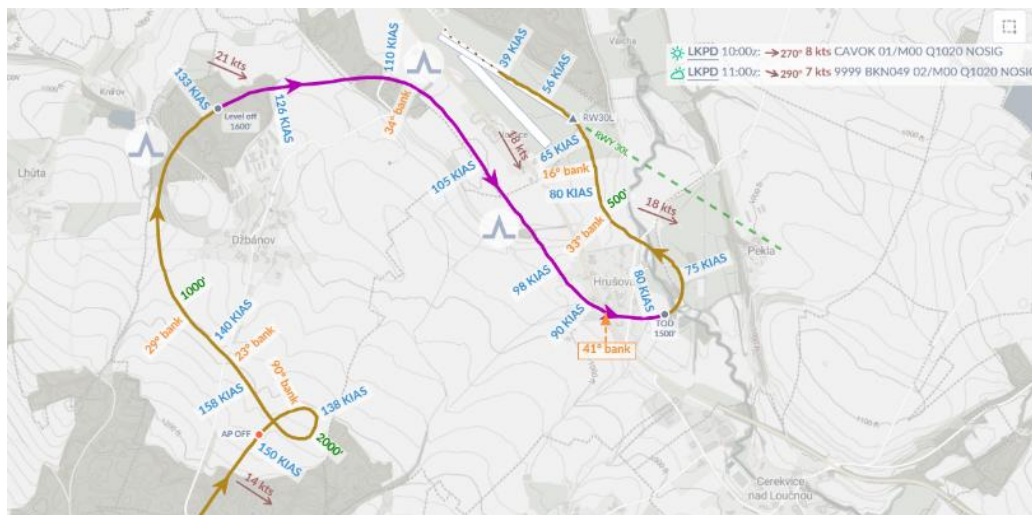
Fig. 2 – Landing manoeuvre of VL 3 UL aircraft, registration mark I-B866, at LKVM on arrival from Italy

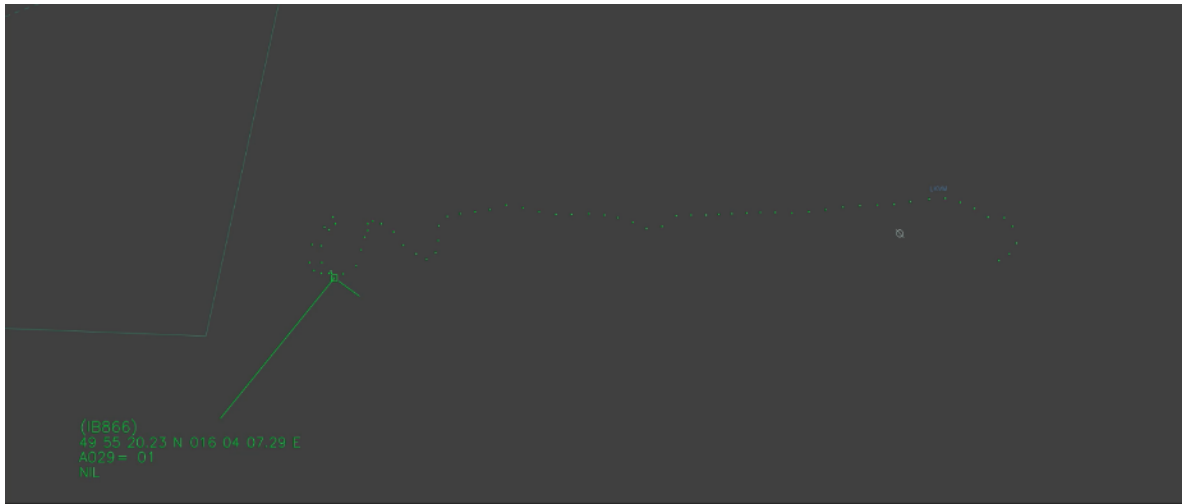
The ACC summary display record showed the route of the event flight at the given place at that time.

Fig. 5 – ACC summary display records

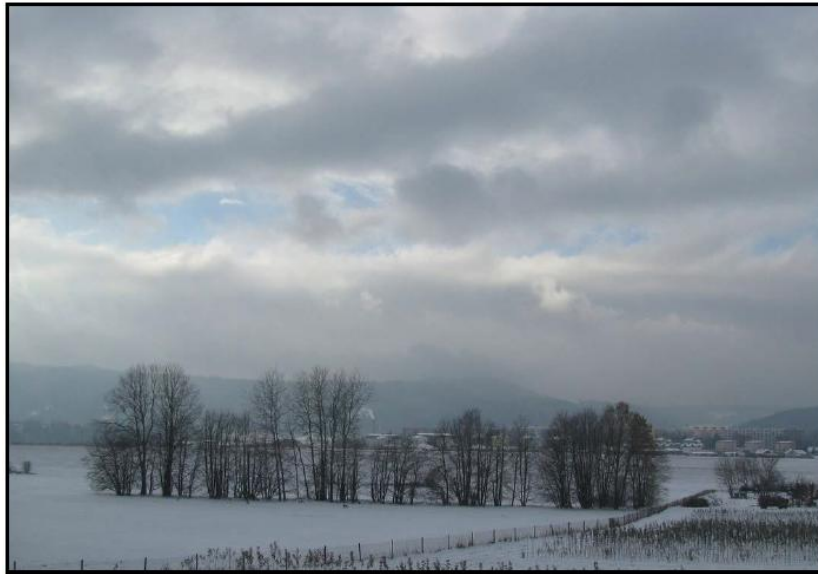
Fig. 9 – Image from the webcam located near the town of Ústí nad Orlicí  
(view southwest/time 12:00)

The wind was blowing mainly northwest at 5 to 10 kt in the area of the air accident near the village of Pěšice at 12:15. Visibility was up to 10 km with occasional mist. The sky was almost cloudy on the whole route of the flight up to the border with Austria with mostly low clouds of ST or SC type. The temperature fluctuated between minus 2 to plus 2 °C. It is likely that frost, which was also predicted from 600 m, may have formed due to the low cloud cover and negative temperatures.

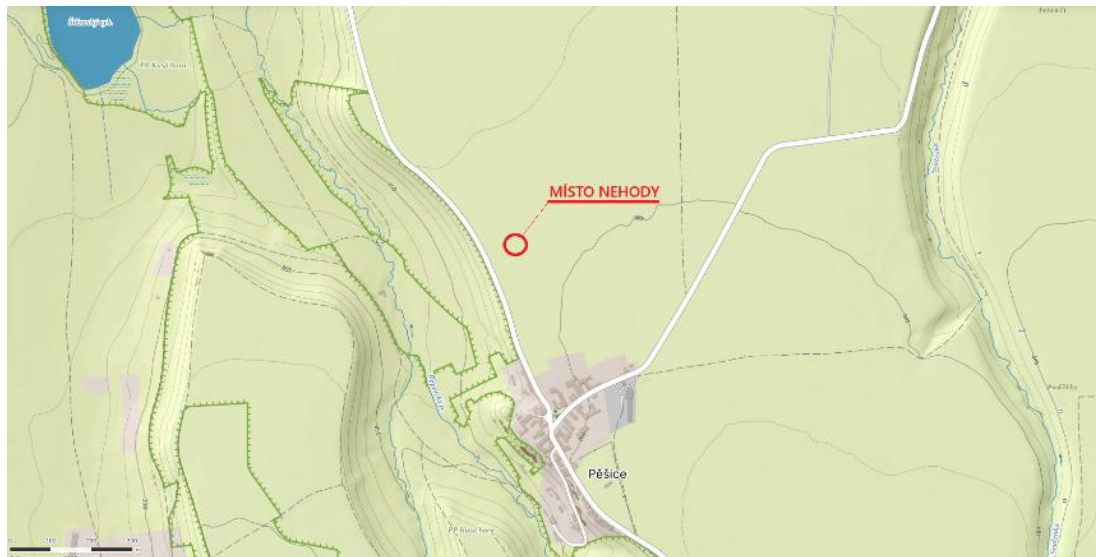
Fig. 11– Place of the air accident

The wreckage of the UL aircraft was lying in the belly-down position, in one place, in one piece. The nose was facing southwest and was partially buried in ploughed, waterlogged soil. The two wing halves remained joined to the fuselage. The flaps and landing gear were in the retracted position. The cockpit canopy was torn from its locking latch and destroyed

by the impact. The deformed frame of the cockpit canopy was broken in the front part and lay behind the left wing half in close proximity to the fuselage. Fragments of the organic glass of the cockpit canopy were located in close proximity to the fuselage. The tail surfaces remained intact, the elevator balancer was in the uppermost position. The elevator and rudder were attached to the control rods and cables. The rudders could be moved freely and were not damaged.
