CZ-23-1016

# **FINAL REPORT**

**of serious incident  
of aircraft Boeing 767-332ER(WL)  
registration N175DN  
on 1<sup>st</sup> of September 2023  
during initial climb from LKPR**

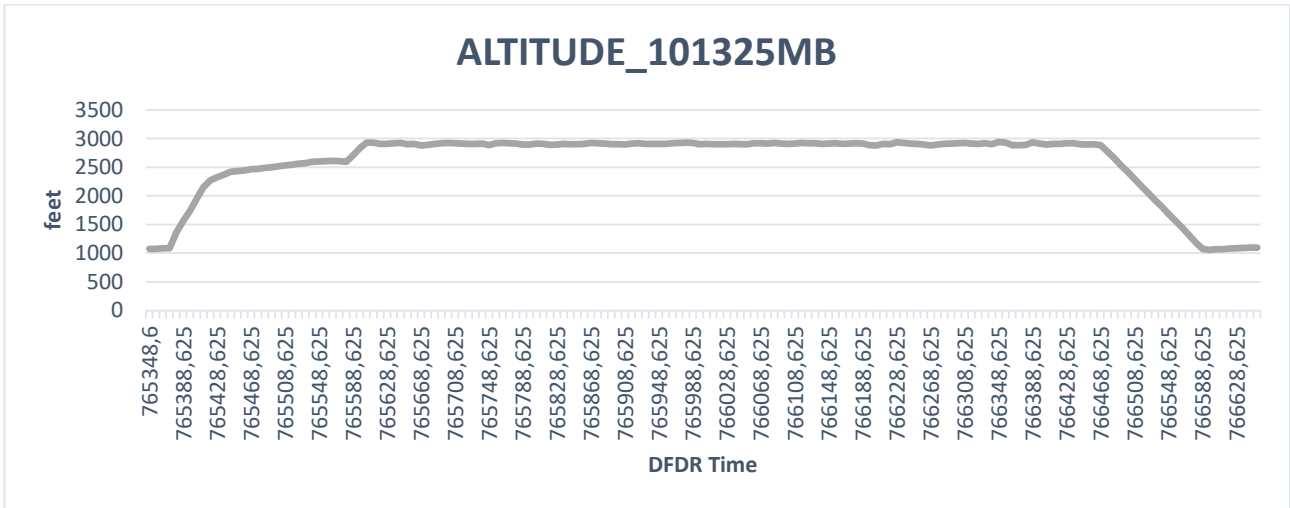
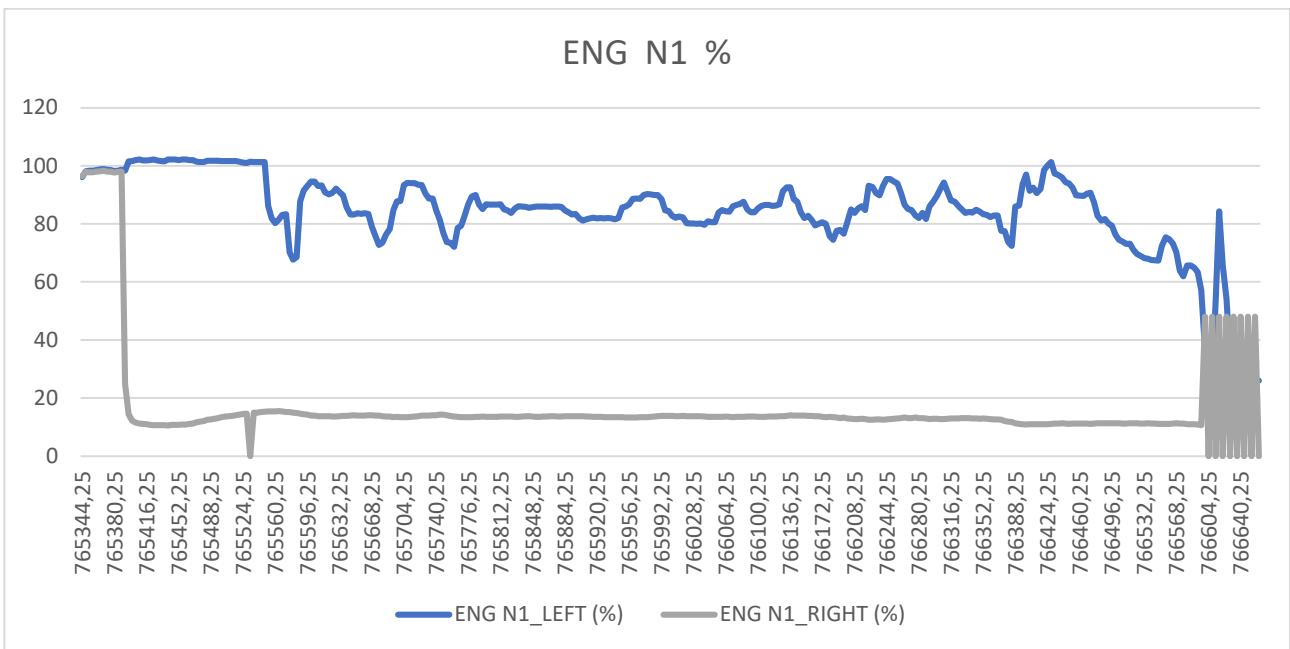
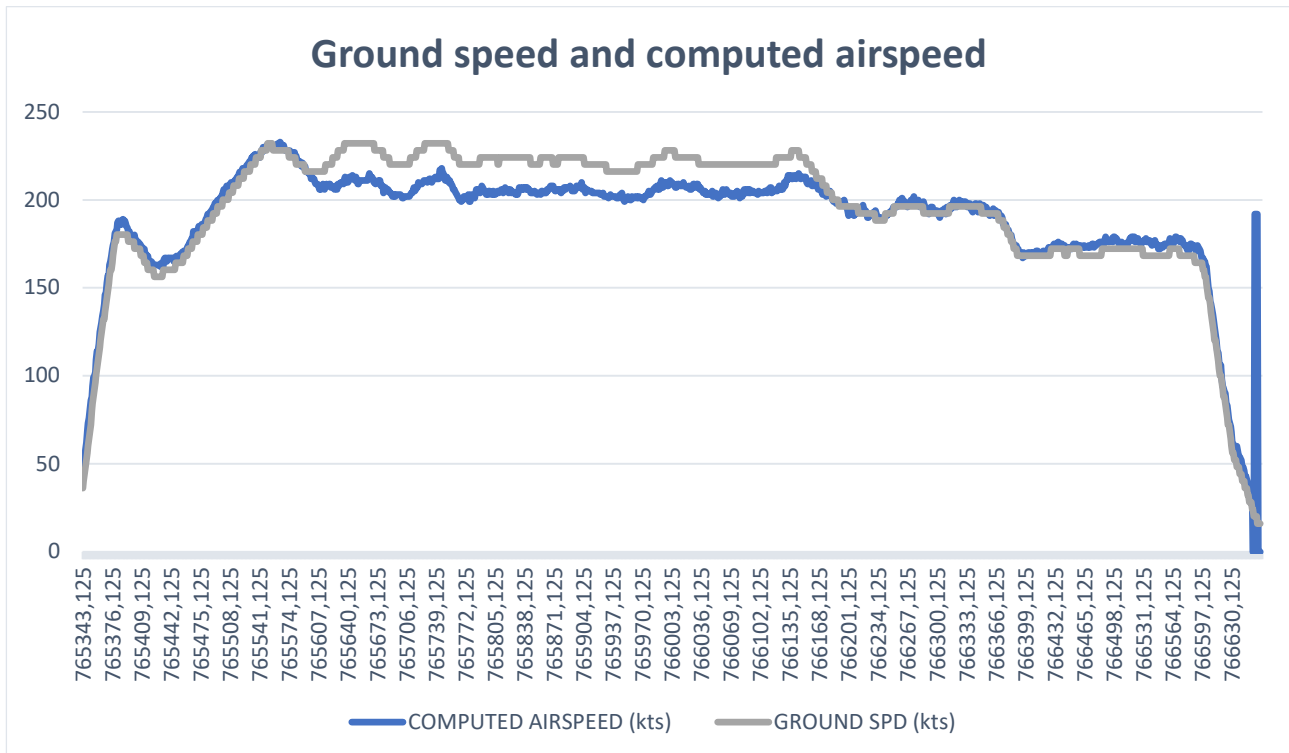
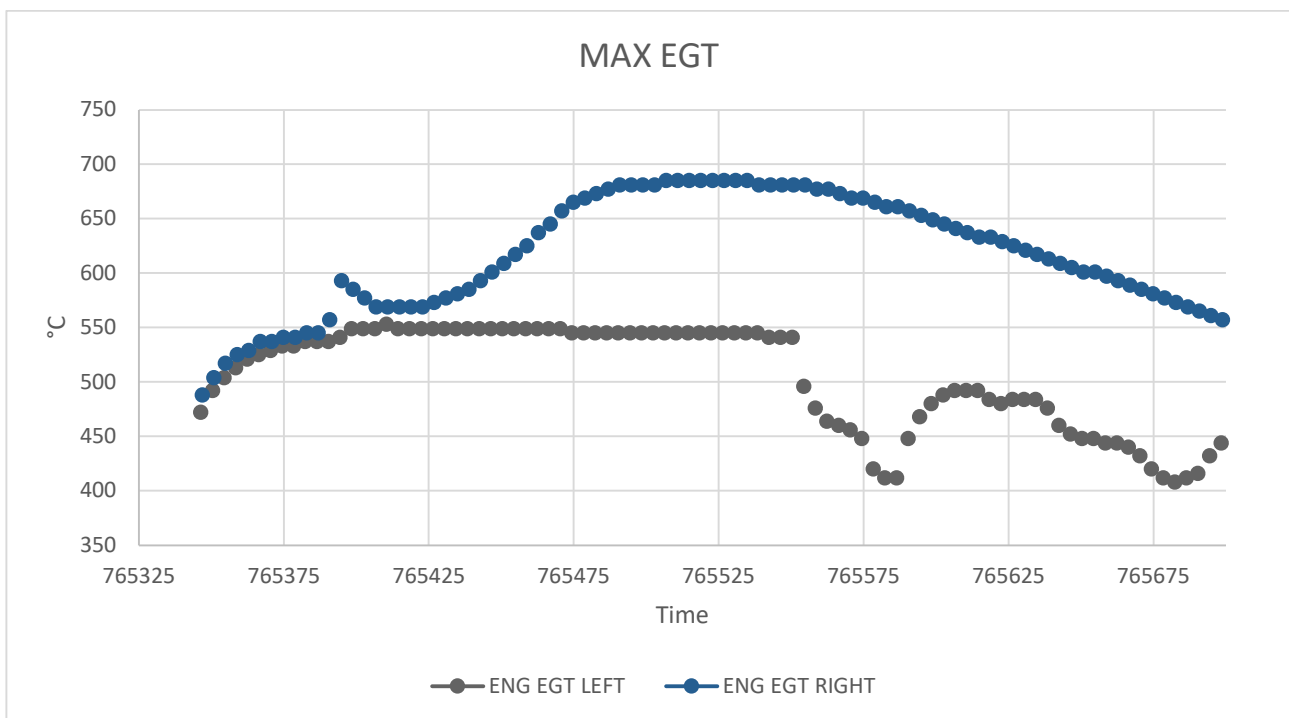
The DFDR showed the following:

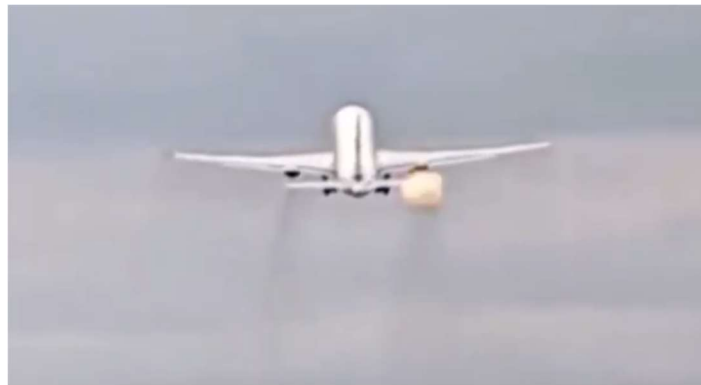
Fig. 4: Photo taken during the take-off<sup>4</sup>

There was no evidence of in-flight engine fire. The recorded engine fire parameters did not indicate a fire at any point during the flight.

The affected engine suffered in flight failure and the flameout was the effect of the malfunction.
